PROPANE EXPLOSION: A CASE STUDY

03/01/2005

BY ERIC G. BACHMAN

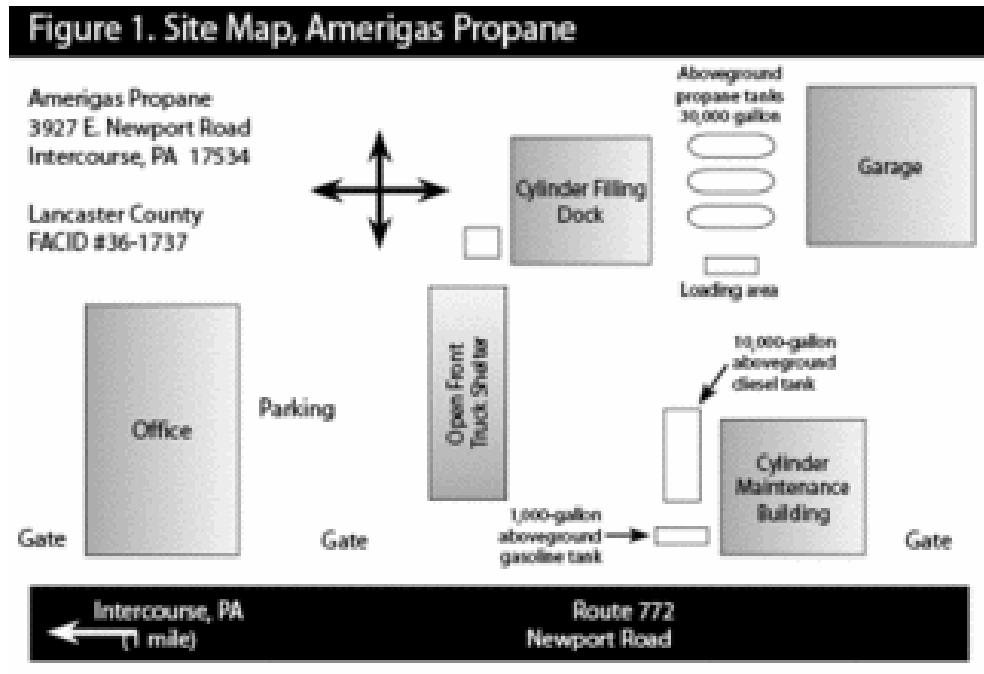
Figure 1

The facility, owned and operated by Amerigas Propane, is a residential and commercial propane supply and distribution site. The property itself is comprised of several buildings that include an office building, a cylinder filling dock, a garage, a cylinder maintenance building, and an open truck shelter. The facility maintains an extensive inventory of propane, including dozens of portable cylinders and fixed aboveground propane storage tanks. In addition to the portable units and the three 30,000-gallon aboveground storage tanks, the site also maintains a 10,000-gallon aboveground diesel fuel tank and a 1,000-gallon aboveground gasoline tank. Both are close to the cylinder maintenance building (see Figure 1).

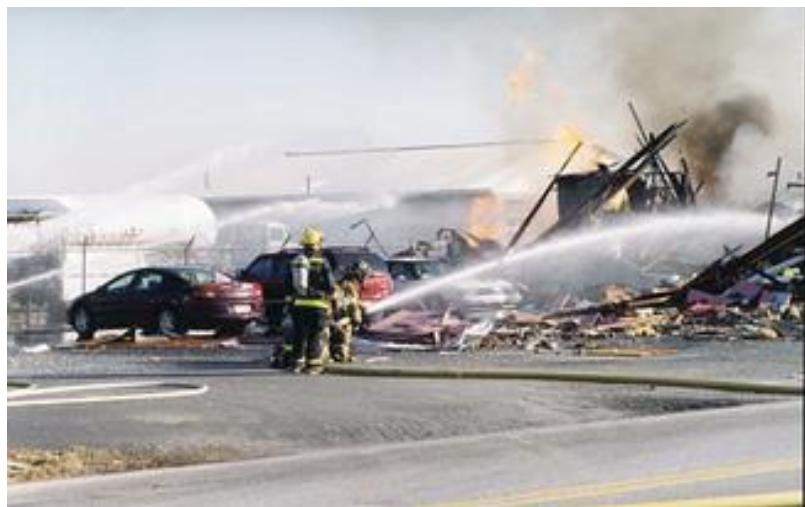
(10) Bravo side of the building; the vapor of the overturned tanks generated much heat.

The 100-gallon cylinders were situated outside the cylinder maintenance building, primarily on the west and north sides, and presented an extraordinary challenge. When the building exploded, debris landed on top of this inventory, providing a shield from the cooling water streams. This caused some tanks to be unprotected, initiating pressure relief valves (PRV) and influencing thermal stressors on other tanks. Some tanks were knocked on their sides as a result of the explosion. When the PRV on these overturned tanks activated, the vapor ignited, resulting in a horizontal flame that impacted other cylinders.

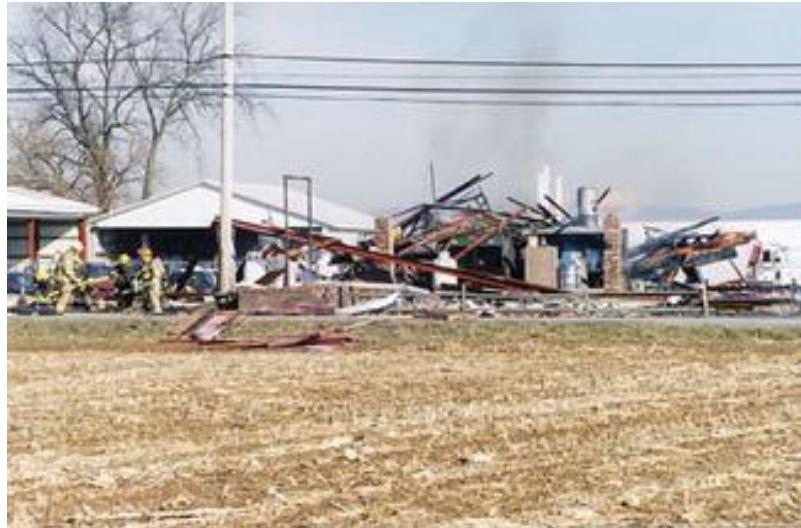
(11) Alpha side of the building. Note the 100-gallon tanks to the left, center, and right of the photo.

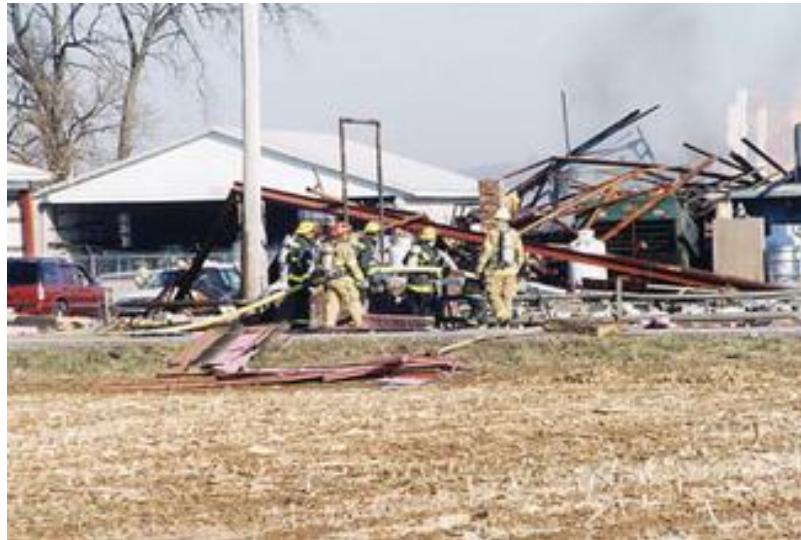
(12) Firefighters survey the damage at the Alpha side. The heat being generated in the right of the photo indicates the incident is still active.

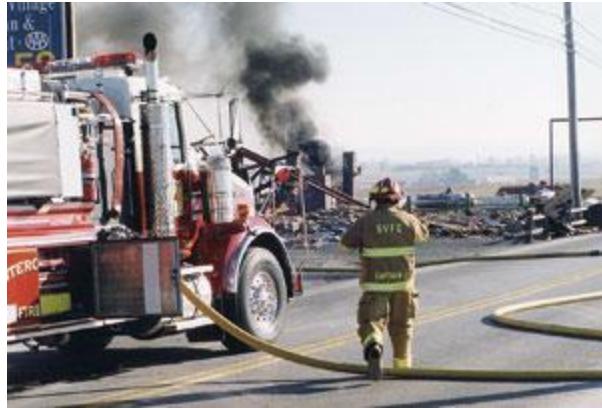
(13) Note the close proximity of the fire apparatus. One lesson learned was the importance of site management and control. The properties of propane and the potential for a BLEVE significantly increased the risk to personnel.

- The importance of site management and control. A point discussed was the closeness of personnel and equipment to the scene.
- We should have initiated evacuation of neighboring exposures. Fortunately, the incident occurred during the Christmas break, and a large high school located a mile southeast of the incident was vacant. The critique identified the need to communicate with special-needs facilities to determine the best means of protecting occupants, whether evacuation or sheltering in place.
